Service Bulletin

COPIER

Model : GP405/335

No.: GP405-011
(FF-T01-J7-000030-01)

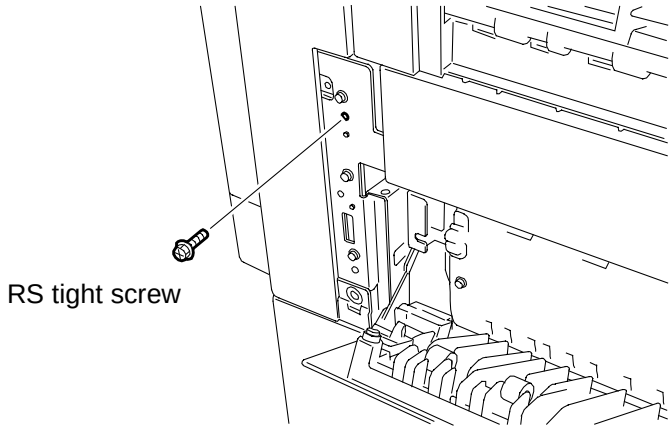
Location : MAIN UNIT LEFT SIDE PANEL

Reason : Upon shipment from the factory, some of the MULTI-OUTPUT TRAY-D1 fixing screws have untapped holes. This is to describe the field fix and countermeasure.

Details : < FIELD FIX >
When mounting the MULTI-OUTPUT TRAY-D1, the hinge (FB4-3791-000: Parts calatogue FY8-31CK-020 Q10-3) is attached to the copier main unit, but due to a mistake during assembly, some were shipped out with screws that have untapped holes. The field fix is as follows:

Remove the RS tight screw that secures the Front Left Cover (FB4-3233) and use it to tap the screw hole in the location shown in the diagram below.

Then, mount the MULTI-OUTPUT TRAY-D1 hinge.
