Service Bulletin

Model : GP605

No.: GP605-001
(FF-T01-K1-000003-01)

Subject : DAMAGE TO MICROSWITCH INSIDE REGISTRATION / TRANSFER ASSEMBLY

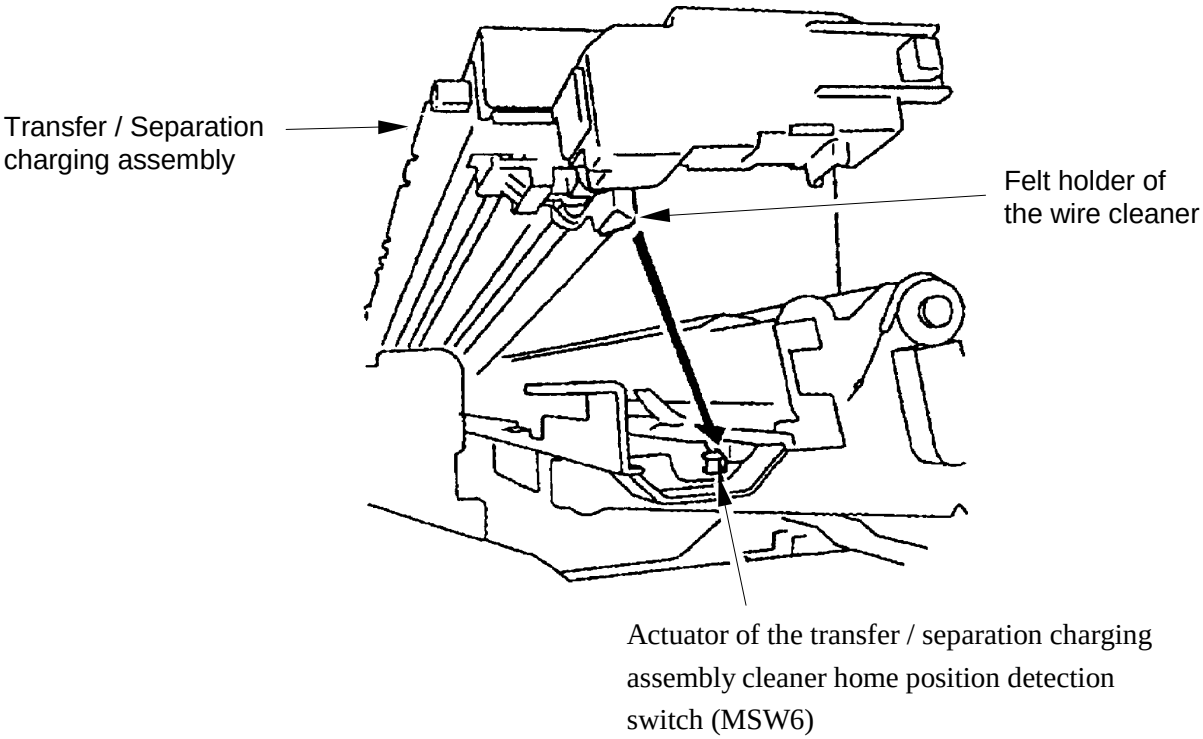
Fig. 2

<Cause>
When installation of the transfer / separation charging assembly is performed with the felt holder of the wire cleaner of this assembly at the home position, the protruding part of the felt holder comes into contact with the microswitch actuator in the registration / transfer assembly. And depending on how this contact is made, the actuator may deform or detach to result in the quality problem (error code E063).

* If the wire cleaner is not moved to the center, it may come into contact with the microswitch actuator at the home position as shown in the figure below, causing deformation or detachment.
