Service Bulletin

Model : GP605

No.: GP605-005 Rev. 1
(FF-T01-K1-000009-02)

Subject : PREVENTING JAMS WHILE READING AN ORIGINAL

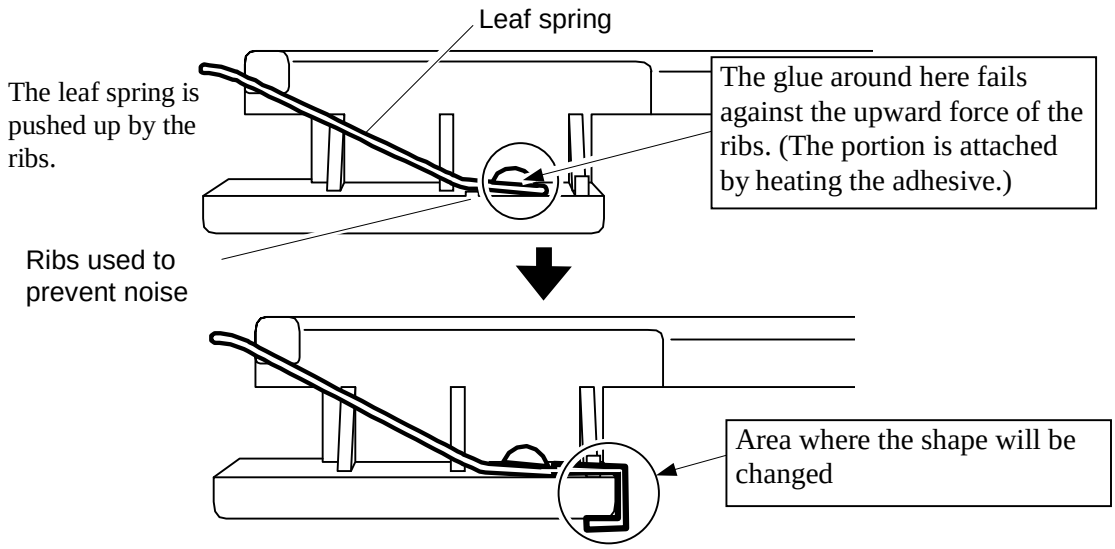
Fig. 1

<Cause>
A portion of the leaf spring of the slide guide (rear) found on the ADF pickup tray can fail against the upward force of the ribs found under the spring, resulting in detachment.

- Tentative Measures
  The ribs of the slide guide (used to prevent noise; see the figures below) are shaved off to limit the stress against the glued portion (switch-over on and after March 30, 1999).

- Permanent Measures
  In addition to the tentative measures above, the shape of the leaf spring will be modified to prevent stress on the leaf spring (see the figures below; switch-over on and after April 13, 1999).
