SERVICE BULLETIN

MODEL NAME : Di620
MODEL CODE : 1155
NO. : 005
DATE : 980702
SUBJECT : HARNESS CHANGE

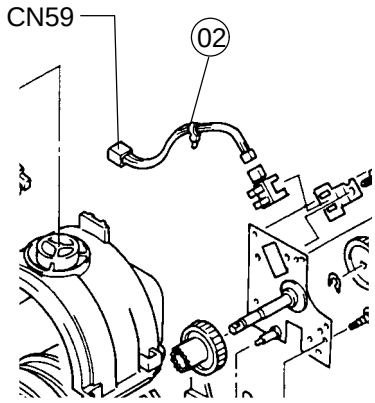
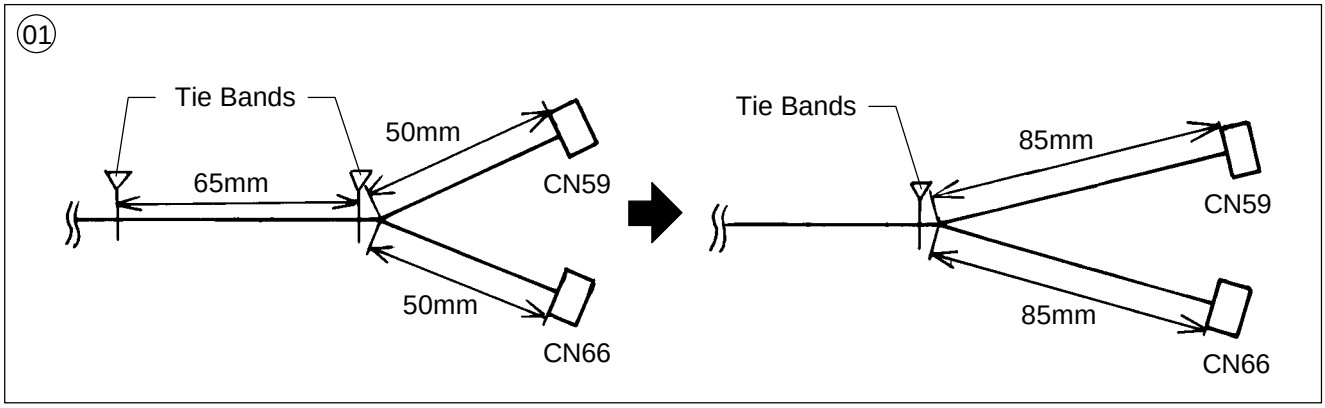
1. For harness 01, the position of the tie band has been changed.
2. For harness 01 and 02, CN59 was changed from a CT connector to an SMP connector.

NOTE: The new harnesses (01, 02) must be installed in premodification machines together as a set.
