SERVICE BULLETIN

MODEL NAME : Di620
MODEL CODE : 1155
NO. : 011
DATE : 981007
SUBJECT : SOFTWARE PROGRAM OF IC70B ON PWB-B CHANGE

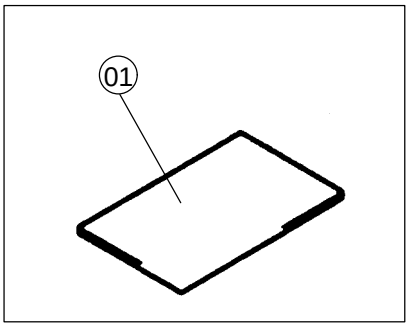
The software program of IC70B on P.W. Board-B has been changed and the following problems have been solved. Due to this, the memory program of the memory card IC (01) has been changed.

IC70B Version : 10G019-00 ➡ 10G032-00
