SERVICE BULLETIN

MODEL NAME : Di620
MODEL CODE : 1155
NO. : 012
DATE : 981007
SUBJECT : TAKE-UP MISFEED IN C-304L

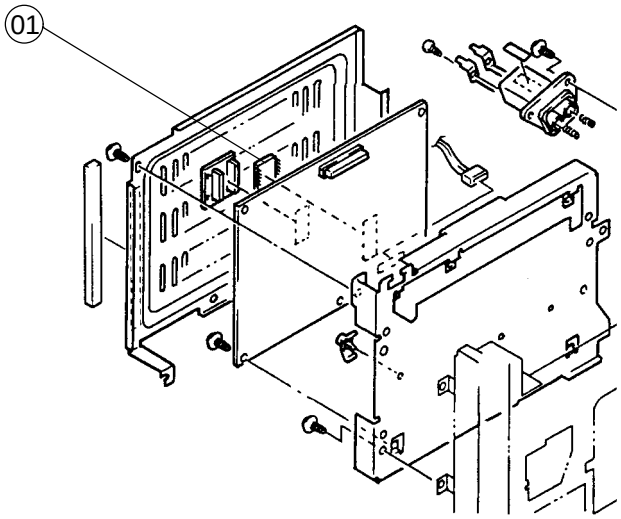
PROBLEM: In the C-304L, there is a possibility that the paper feed motor may be driven erroneously (backward), causing a take-up misfeed to occur.
CAUSE: There is a bug in the software program.
SOLUTION: The software program of IC2A (01) on P.W. Board-A has been changed.
