SERVICE BULLETIN

MODEL NAME : Di620
MODEL CODE : 1155
NO. : 030
DATE : 990408
SUBJECT : NEW PM PART

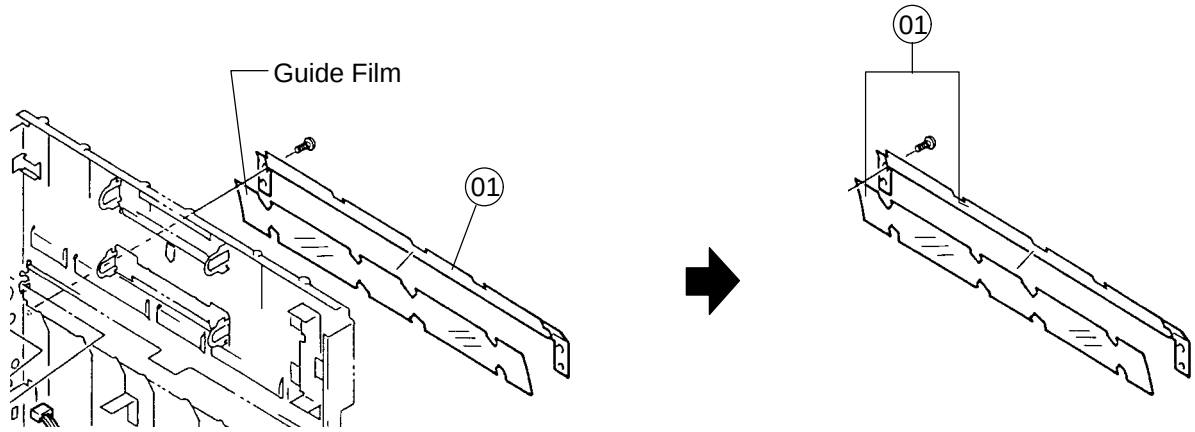
The guide film in the turnover section has been designated as a PM part. The replacement cycle is shown bellow. To make replacement in the field easier, the guide (01) has been changed to the guide plate assy (01) with the guide film affixed.

NO.	BEFORE MODI. F-IND	BEFORE MODI. PART NO.	AFTER MODI. PART NO.	AFTER MODI. F-IND	PART NAME	QTY →	I	SE/NO.	AREA
01	33-39AA	1155-3821-01	1155-0755-01	33-39AB	GUIDE PLATE ASSY	1 1	Y	- - - - - -	0000
