SERVICE BULLETIN

MODEL NAME : Di620
MODEL CODE : 1155
NO. : 035
DATE : 990602
SUBJECT : CHANGE OF CABLE MOUNTING BRACKET

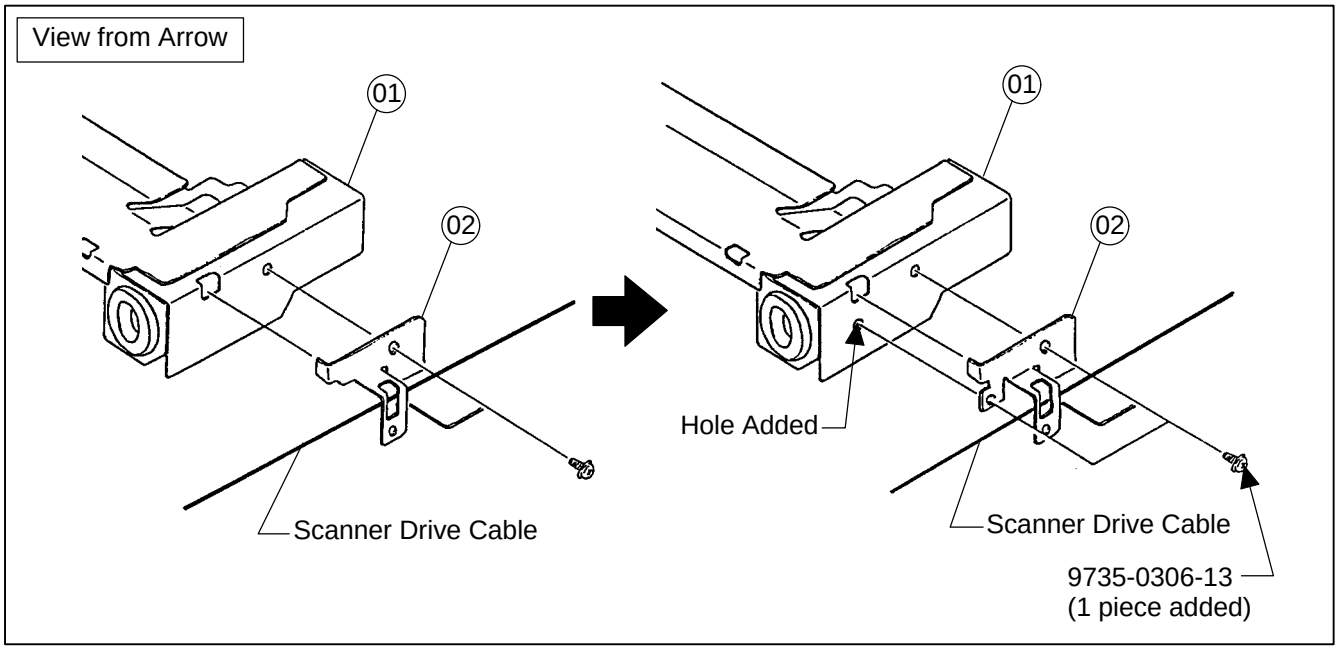
PROBLEM: The Cable Mounting Bracket (02) installed on the Scanner Assy (01) can at times be broken.
CAUSE: When the Scanner is moved, the Scanner Drive Cable interferes with the Cable Mounting Bracket (02), causing the Cable Mounting Bracket (02) to wear.
SOLUTION: The following changes have been made to increase the strength of the Cable Mounting Bracket (02).
-The shape of the Cable Mounting Bracket (02) has been changed.
-A Screw hole has been made in the Scanner Assy (01).
-As a result of the change made in the shape of the Cable Mounting Bracket (02), a tapping screw (9735-0306-13) has been added.

NOTE: The new Bracket (02) must be installed in premodification machines with the new 1st Slider (01).
