SERVICE BULLETIN

MODEL NAME : Di620
MODEL CODE : 1155
NO. : 038
DATE : 990714
SUBJECT : C0110 DISPLAY

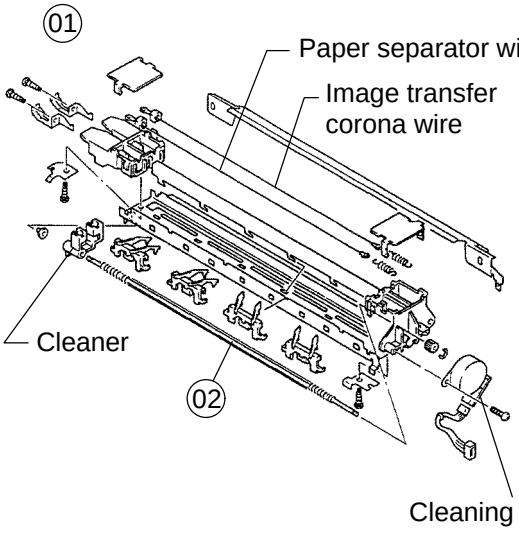
PROBLEM: There is a possibility that malfunction "C0110" may at times occur due to the malfunctioning corona wire cleaning mechanism of the image transfer/paper separator coronas unit (01).

CAUSE: The corona wire cleaner moves back and forth on the corona wire, controlled as detailed below. If, however, there are variations in the accuracy of parts of the image transfer/paper separator coronas unit (01), the cleaner reaches the very end of the screw of the transport shaft (02) and goes beyond the screw part before 11.6 sec. elapse after the cleaning motor (M8) has started turning forward.

SOLUTION: The screw part of the transport shaft (02) has been made longer to give allowance for the cleaner motion.
