REPLACEMENT PROCEDURES OF MODIFID PART
(Shaft : 2mm extended) for the noise from Duplex Unit

99/11/11

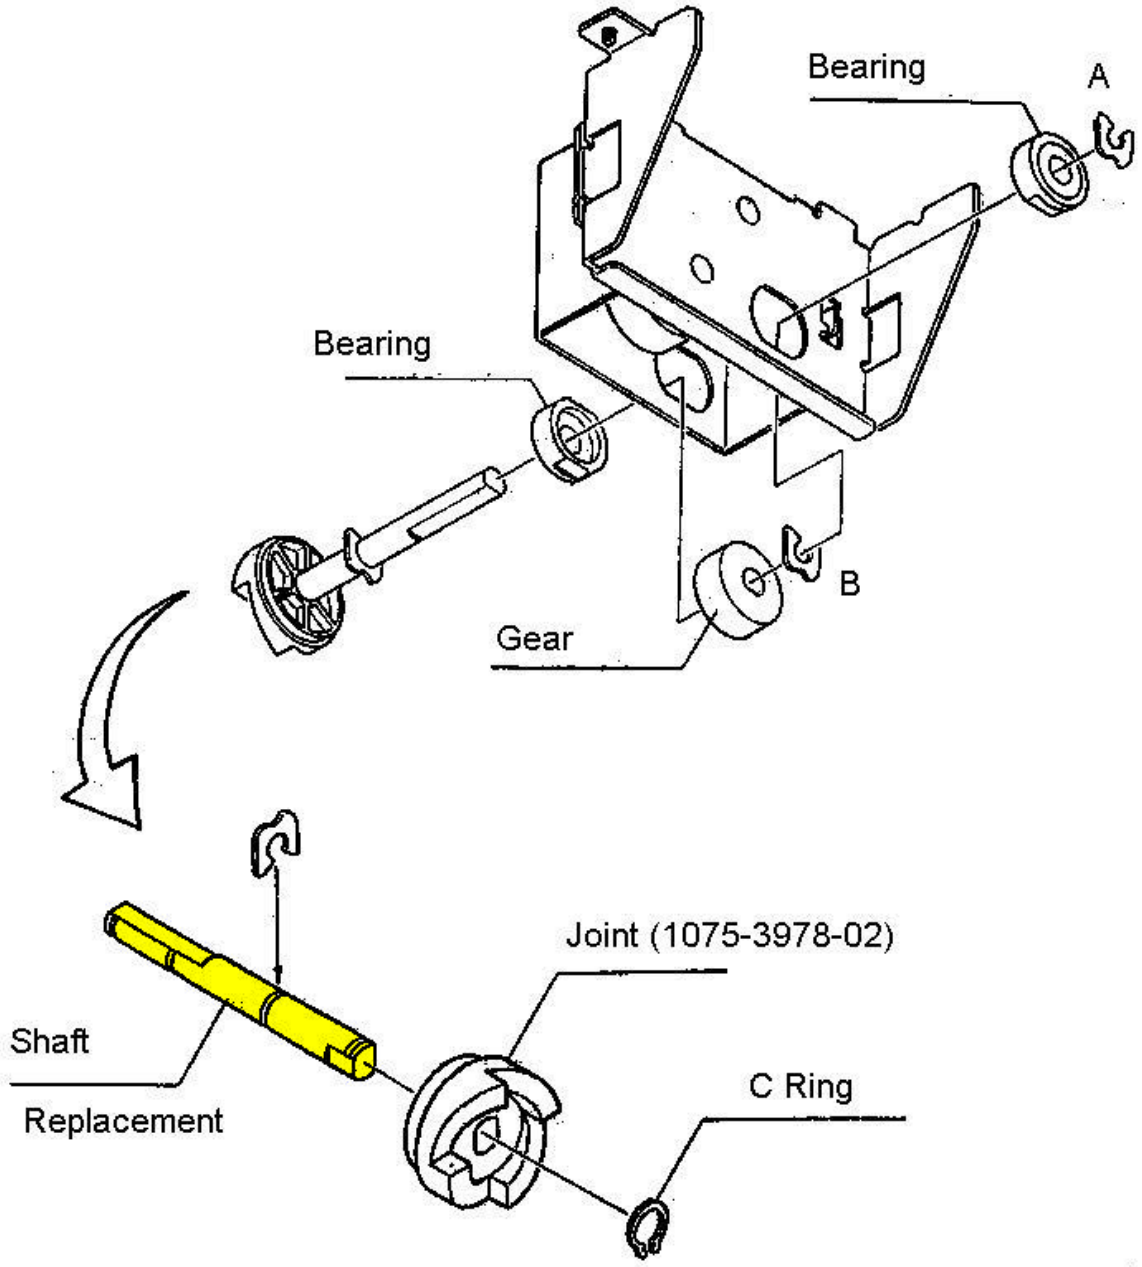
1155-5770-02 ->1155-5770-?(itís not set yet.)

1.Remove the Rear Cover (1155-1003-02).
2. Open the Front Lower Door (1155-1051-02) and slide out the Duplex Unit.
3. Pull out the used Toner Bottle.
4.Replace the Shaft(2mm extended).

1) Remove the E-ring îAî and the Bearing.
2) Remove the E-ring ìBî securing the Gear.
3) Pull out the Shaft.

Opposite order of ìRemoving Proceduresî
