2-12. C0F10: AE Sensor Board PWB-H Malfunction

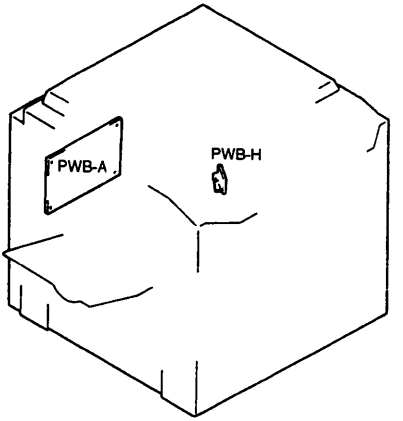
1136T023AA

Symbol	Name
PWB-H	AE Sensor Board
PWB-A	Master Board

Step	Check Item	Result	Action
1	Is the voltage across PJ4AA-6 on PWB-A and GND 0.18 V or less when the Scanner is at its home position, LA1 OFF, and the Original Cover closed?	YES	Check the photo receiver of PWB-H for contamination or replace PWB-H.
		NO	Replace PWB-A.
