2-13. C0F20: AIDC Sensor UN3 Variation Correction Failure
C0F21: AIDC Sensor UN3 Contamination Correction Failure
C0F22: AIDC Sensor UN3 V_G Correction Failure
C0F23: AIDC Sensor UN3 Exposure Correction Failure

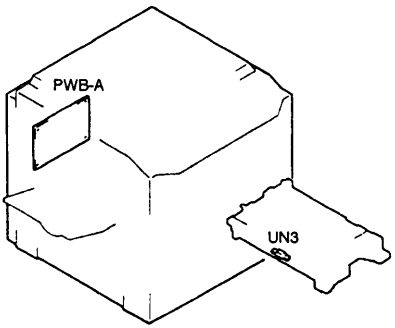
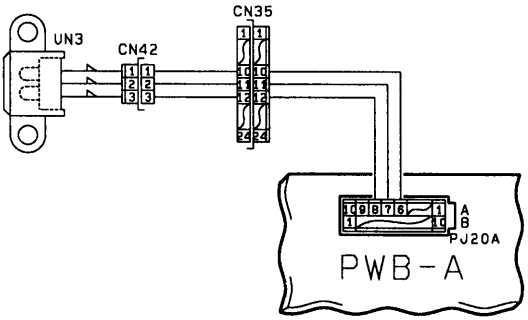
Symbol	Name
UN3	AIDC Sensor
PWB-A	Master Board

Step	Check Item	Result	Action
1	Is PJ20AA plugged securely into PWB-A?	NO	Plug it in securely.
2	Is CN35 connected securely?	NO	Connect it securely.
3	Is UN3 installed at the correct position?	NO	Install it at the correct position.
4	Is the photo receiver or LED of UN3 dirty?	YES	Clean UN3.
		NO	Replace UN3 or PWB-A.
