21) C0d00: Duplex Unit Front/Rear Edge Guide Plate Home Position Detection Failure

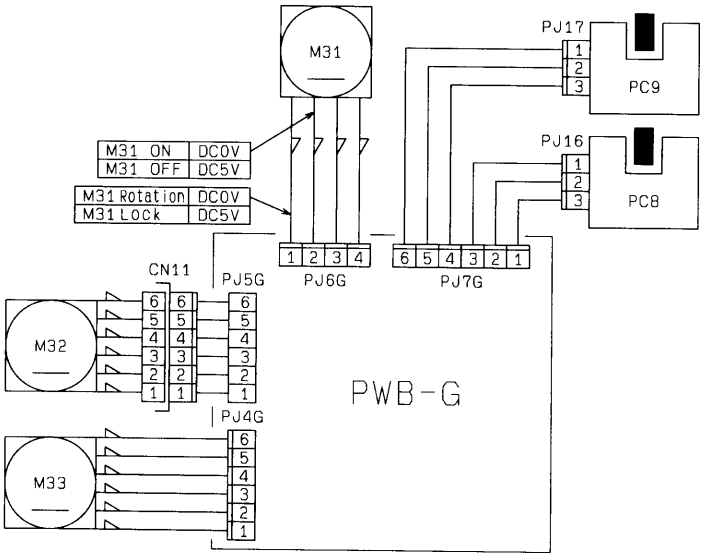
C0d20: Duplex Unit Gate Unit Home Position Detection Failure

C0d50: Duplex Unit Drive Motor M31's Failure to Turn

C0d51: Duplex Unit Drive Motor M31 Turning at Abnormal Timing

Relevant Electrical Parts	
• Duplex Gate Home Position Sensor PC8 • Front/Rear Edge Guide Plate Home Position Sensor PC9	• Duplex Unit Drive Motor M31 • Gate Motor M32 • Front/Rear Edge Guide Drive Motor M33 • AD-9 Master Board PWB-G
