1156SBT040223A

23) C0E20: Image Erase Lamp LA3's Failure to Turn ON

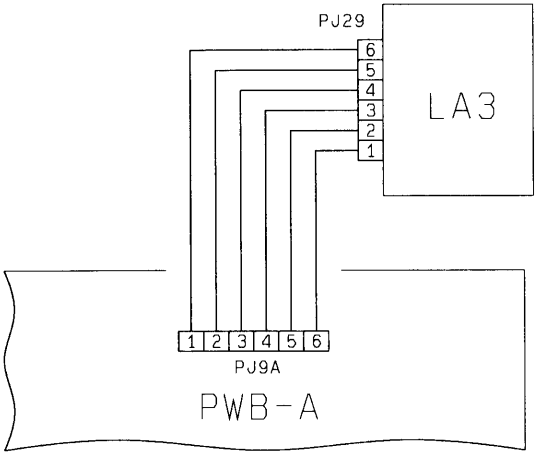
1156C23TAA

Relevant Electrical Parts	
• Image Erase Lamp LA3	• Master Board PWB-A

Step	Check Item	Result	Action
1	Perform the "Controller Board Check." Is malfunction code "C0314 to C0317" displayed?	YES	Change PWB-A.
2	Is the voltage across PWB-A PJ9A-1 and GND DC5V?	YES	Change LA3.
		NO	Check the 5V line.
