1156SBT040227A

27) C0F30: ATDC Sensor UN3 Failure
C0F31: ATDC Sensor UN3 Failure

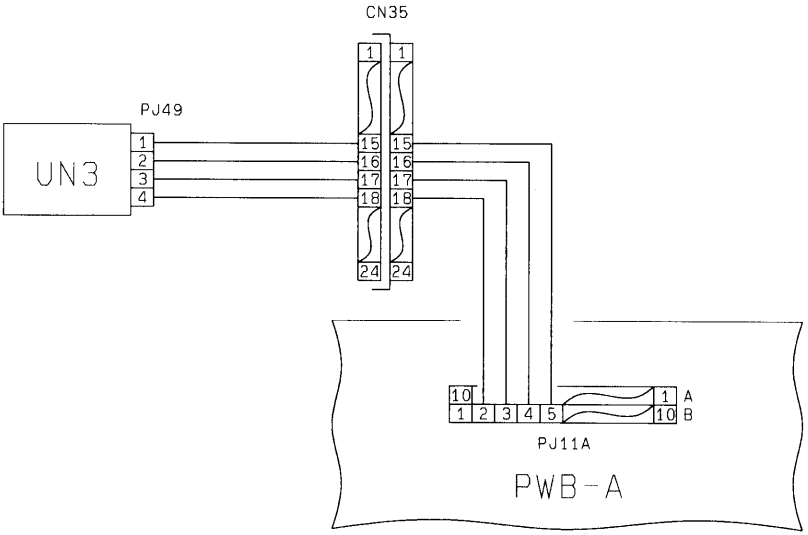
1156C19TAA

Relevant Electrical Parts	
• ATDC Sensor UN3	• Master Board PWB-A

Step	Check Item	Result	Action
1	Is the malfunction code "C0F30" displayed?	YES	Go to step 3.
2	Is the value for "ATDC Ref. Value" of "Level History" equal to the value given on the Adjust Label?	NO	Enter the value given on the Adjust Label.
3	Is PWB-A PJ11A plugged in securely?	NO	Plug it in securely.
4	Is CN35 plugged in securely?	NO	Plug it in securely.
5	Is UN3 installed in the correct position?	NO	Reinstall.
