RICOH **T**echnical **B**ulletin **PAGE: 1/1**

Model: Plover	Date: 15-Sep-98	No: 1
Subject: Point to Point Diagram Revision	Prepared by: H. Someya	
From: QAC Field Information Dept.

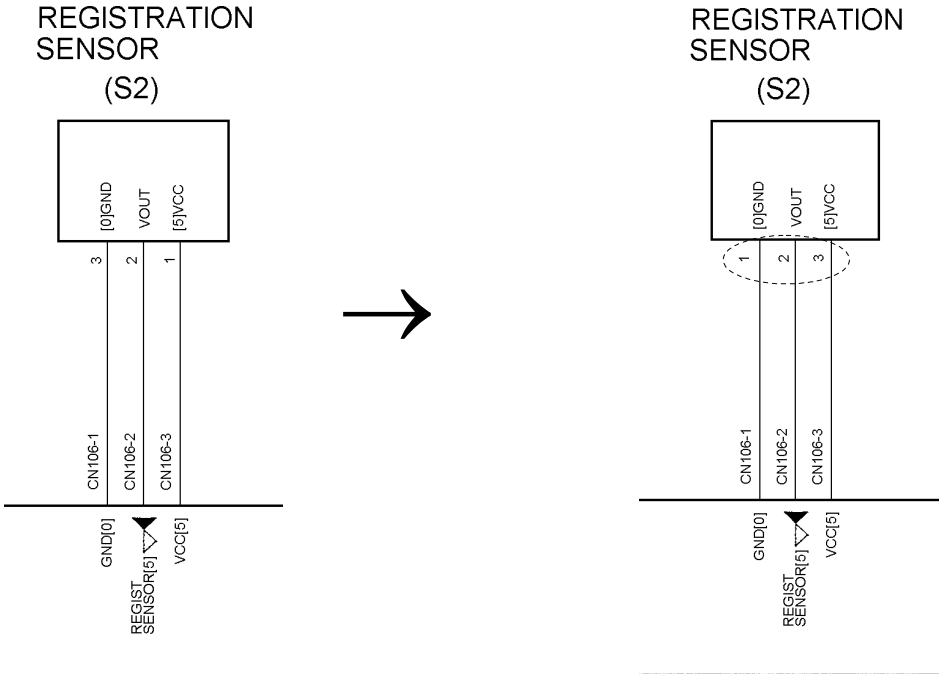
Correct your point to point diagram as follows (registration sensor connector number).
