Service Bulletin

Model : GP335/405

No.: GP405-002
(FF-T01-J7-000008-01)

Subject : NOTES OF CAUTION FOR CCD UNIT INSTALLATION

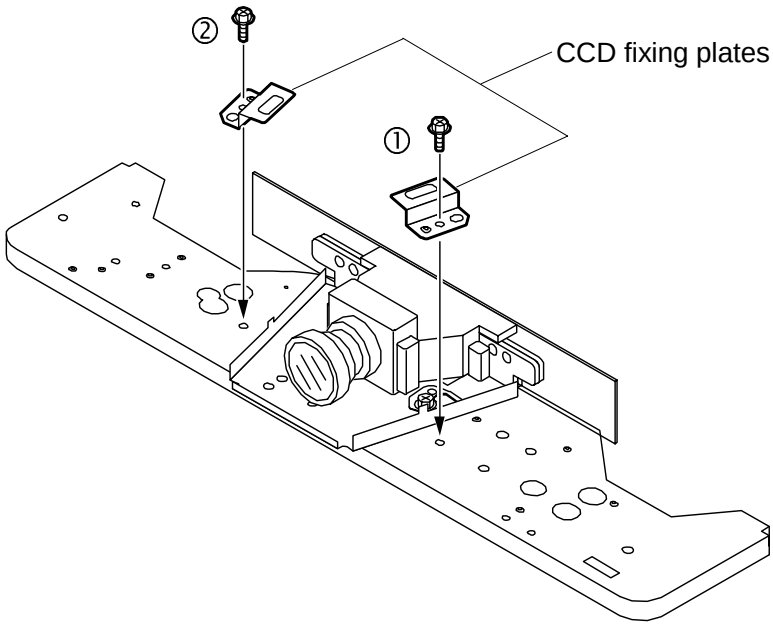
Fig. CCD lens mount

Details : There is a need to exercise caution in removing and installing the CCD unit after shipment from the factory so as to avoid running the risk of a loose fit of the unit to the prescribed position and a failure to maintain the right-angle alignment. Since image verifications, including right-angle alignment, are made at the time of shipping the product from the factory, the only possibility for occurrence of this problem is when the CCD unit is installed or removed during servicing in the field.

Servicing : <Installation Procedure>
1) Tighten the screw ① and check that the fit of the CCD unit is not loose.
2) After checking that, complete the installation procedure by tightening the screw ②.
