Service Bulletin

Model : GP605

No.: GP605-008
(FF-T01-K1-000018-01)

Subject : COUNTERMEASURES FOR GEAR BREAKAGE DUE TO FALLING TIE-WRAP

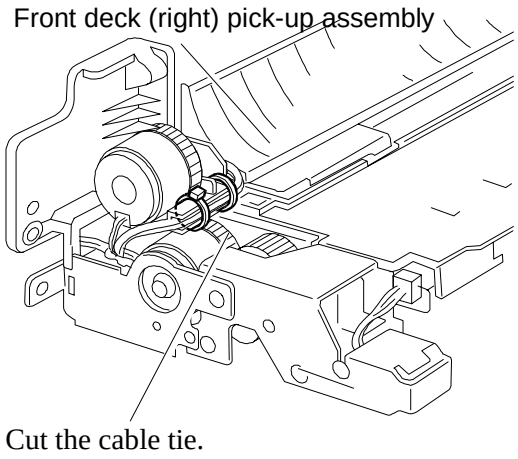
Fig. 1

<Cause>
When the fixing/feeder frame assembly is drawn in and out, tight space inside the machine causes the cable tie which holds the front deck (right) pick up assembly cables to make contact and gets cut. The cut cable tie falls into the front deck (right) gear and the gear drive locks, causing the weakest 20T/32T gear (Parts Catalog FY8-31DU-010 P260-2) in the paper pick-up drive assembly to break.

1) Remove the front deck (right) pick-up assembly.
   (See Service Manual FY8-13FE-000 P7-53.)
2) Cut the cable tie (Fig.1).
3) Accomplish reattachment by following the procedure in reverse.
