Canon

Service Bulletin

Model : **GP160** **GP160DF** **No.:** GP160-007
GP160F **GP160PF** (FF-T01-E40-000050-01)
DATE: 10.08.99

Subject : **Parts Addition**

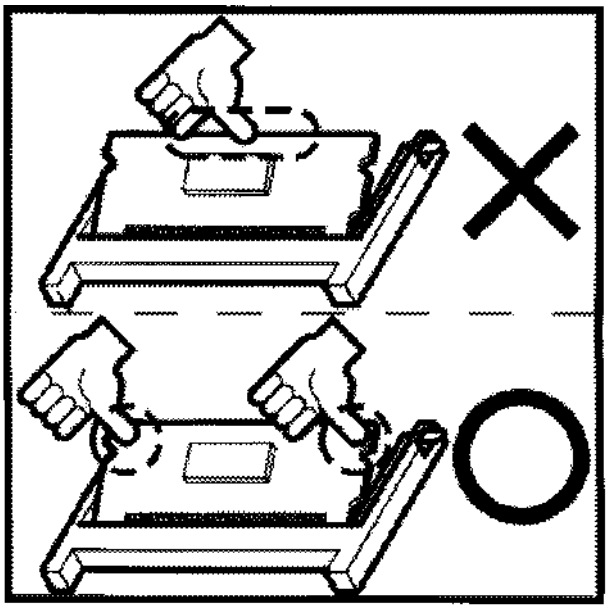
If the dead centre of the DIMM is pressed down forcefully,the pins of the IC chip could lift up.

Seals will be attached at the two points described below,warning not to press down on the middle of the DIMM,but at both ends.
