Issued by Canon Europa N.V.

iR1510
iR1530
iR1570F

iR1200S-011 Rev. 1
(F1-T01-0L6-10005-02)

Points to note for servicing in association with changes of LCD control panel and controller PCB

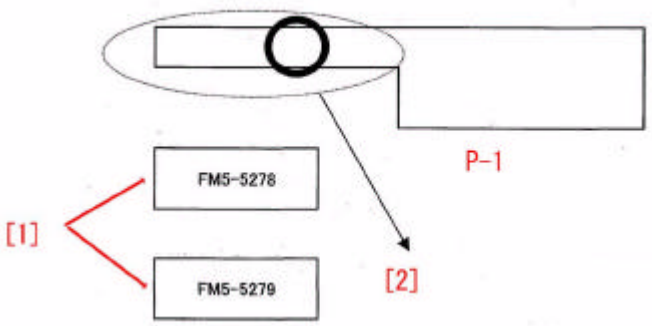
F-1

The LCD control panel and the controller PCB are changed for reasons of procurement. After these changes, the two parts are not compatible in combination of the old and new parts. This bulletin is prepared to inform the points to note for servicing.

P-1: CONTROLLER PANEL PCB ASSEMBLY; Back surface

[1]: Part number label

[2]: Position where a part number label is affixed

Both the old and new parts of the LCD and the controller PCB are stocked as service parts. When replacing the LCD or the controller PCB, be sure to check if it is the old type or the new type (a part number label is affixed on the back of the new-type part as shown in the illustration below), and replace the old type with the old type, and the new type with the new type.
