SERVICE BULLETIN

MODEL NAME : Di620
MODEL CODE : 1155
NO. : 040
DATE : 990729
SUBJECT : HARNESS CHANGE

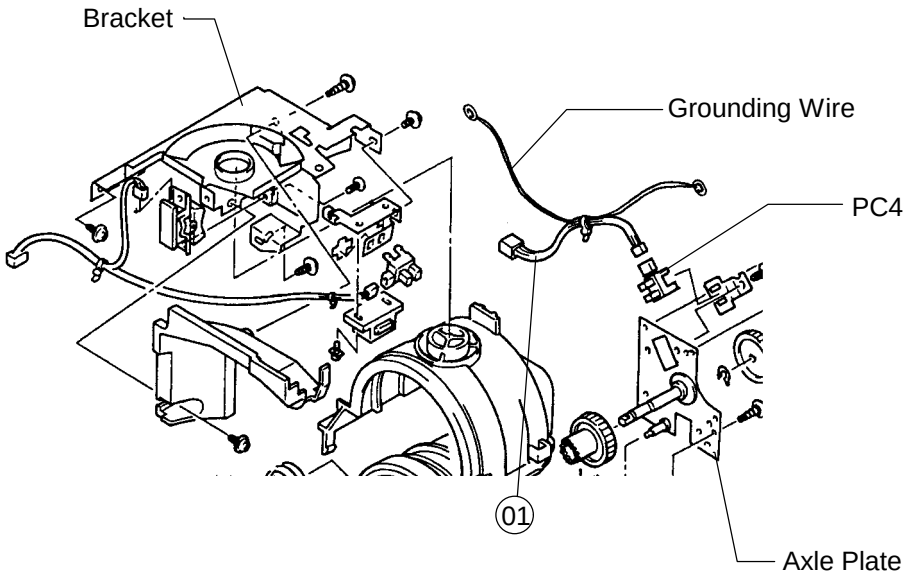
To protect the toner bottle home position sensor (PC4) from static electricity, a grounding wire has been added to the harness (01). The grounding wire is secured with the bracket and axle plate.
